# Inspection actual condition of press

G/075941-01, NCC, Bristol, UK

<b>Kunde:</b> <b>Customer:</b>	NCC, Bristol, UK	<b>Servicetechniker:</b> <b>Service Technician:</b>	Grund/ Schwenger
<b>Type:</b> <b>Type:</b>	SH-3600-3.6x2.4	<b>Maschinen-Nr.:</b> <b>Machine-No.:</b>	G/075941-01
<b>Baujahr:</b> <b>Build year:</b>	2014	<b>Auftrags Nr.:</b> <b>Contract No:</b>	309203
<b>Ansprechpartner:</b> <b>Contact person:</b>	Paul Stenner	<b>Datum:</b> <b>Date:</b>	21.04.2026

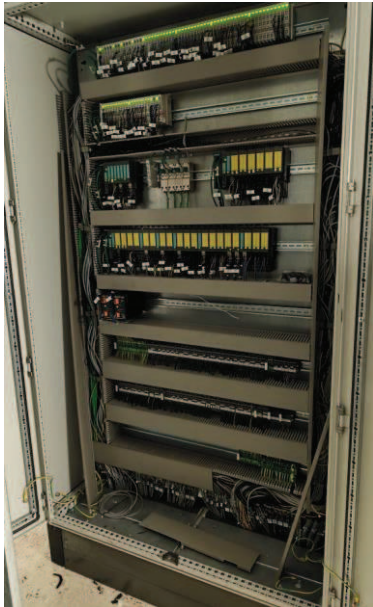
### Distributor box +51T1 pit:

All in good condition.

One Beckhoff module was changed.

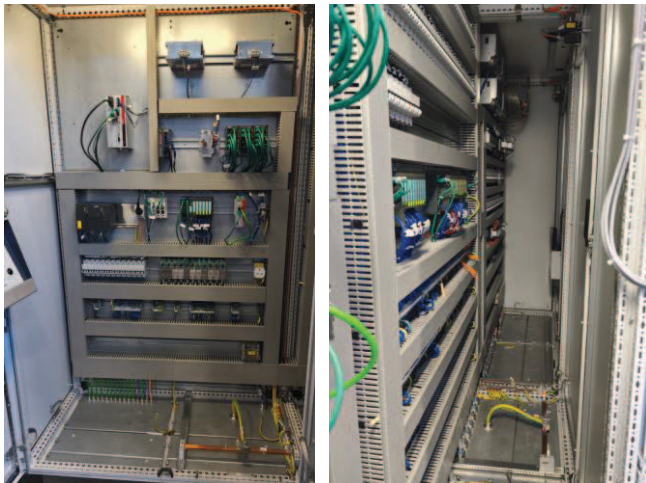
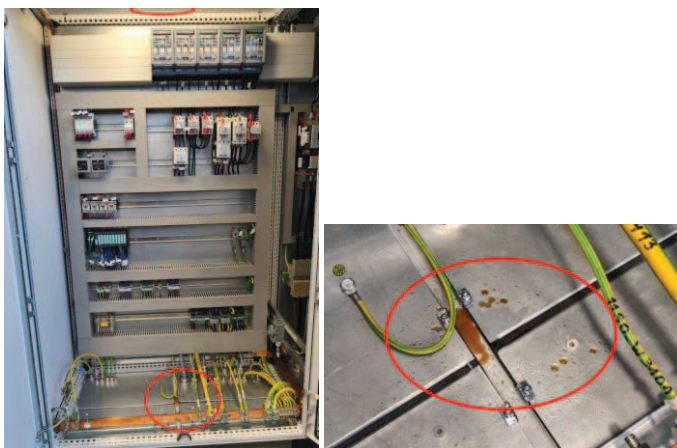
### Cabinet +S1:

**Water-oil-mix is coming down from the valve on the top of cabinet.**

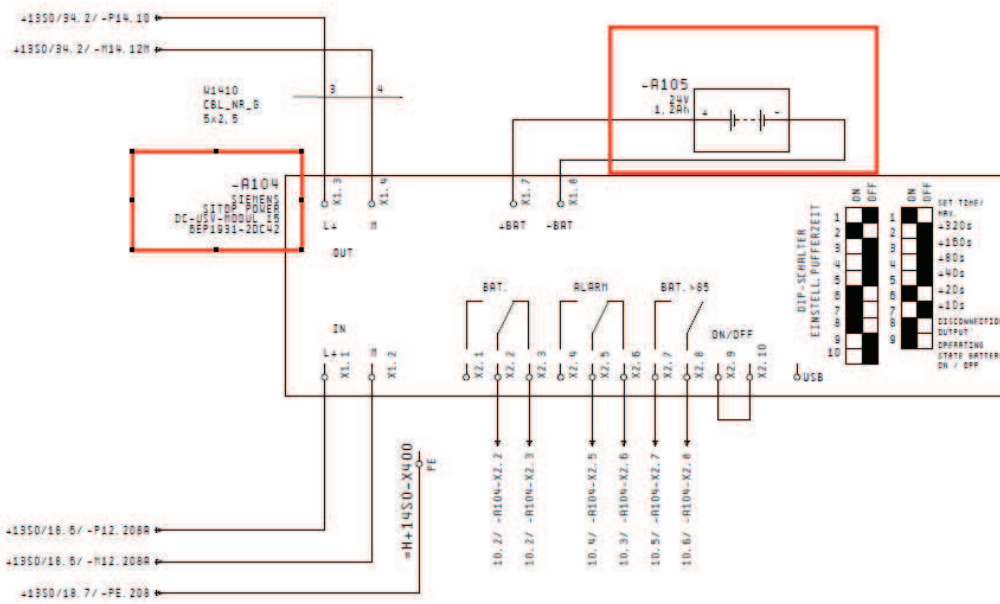
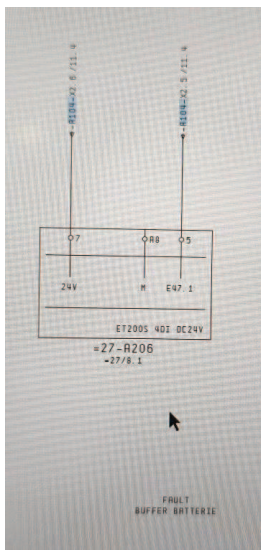
Most in Good condition, only one faulty Power supply.

Accupack -A105 is damaged.

Input fault message

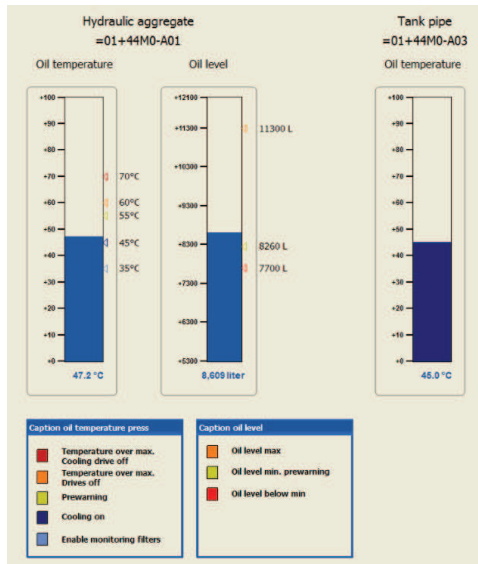
The oillevel is in a good range (8796 Liter).

The oiltemperatur is in good range (50.9°C).

Ideal oiltemperatur is 50°C.

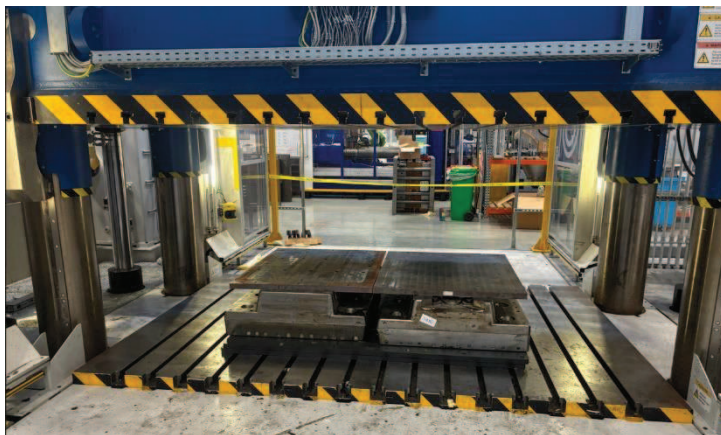
A suitable tool capable of operating at maximum pressing force is no longer available.

NCC improvised and obtained metal plates and two unused tool components, each 430 mm high, for functional testing. The dummy tool measures 2000 x 1200 mm, which, according to the nameplate, is actually insufficient for the maximum force.

However, it is absolutely impossible to operate the press at 45,000 kN to loosen the clamping nuts of the columns.

The clamping surface of the ram-table must be uniformly, ideally almost completely, fitted with appropriate parallel intermediate supports.

The operating pressures for the lower pistons must be increased accordingly to achieve a force of > 45.000 kN. Then the upper nuts can be loosened.

To record the nut positions for alignment, the position of each nut should be marked before loosening.

The lower nuts must then be removed to dismantle the columns. Marking the nut and column is mandatory.

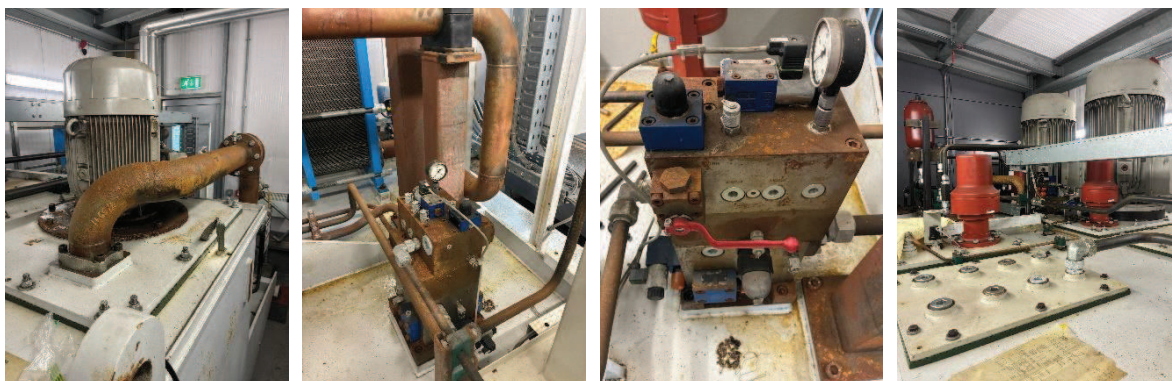
### Hydraulic Unit Inspection

The hydraulic unit is largely leak-free, and the pumps run smoothly. The pump flow rates and pressures are perfectly fine. The unpainted pipes and control blocks show significant surface corrosion. The seals on the pipes and valves should be replaced due to age. The elastic elements on the pump jaw couplings should also be replaced.

Some of the hoses are also hardened.

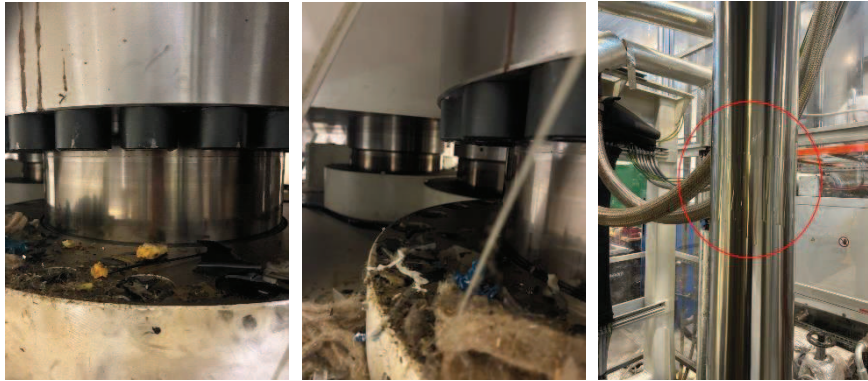
### Cylinder Unit Inspection

The front left ram cylinder is now leaking significantly; the remaining cylinder units are seeping at the rod seals. It is recommended to reseal before recommissioning using appropriately modified wipers. Another option is to install bellows to protect the piston rods from resin residue.

The cylinder units on the table are heavily contaminated with resin residue but appear visually sound and leak-free.

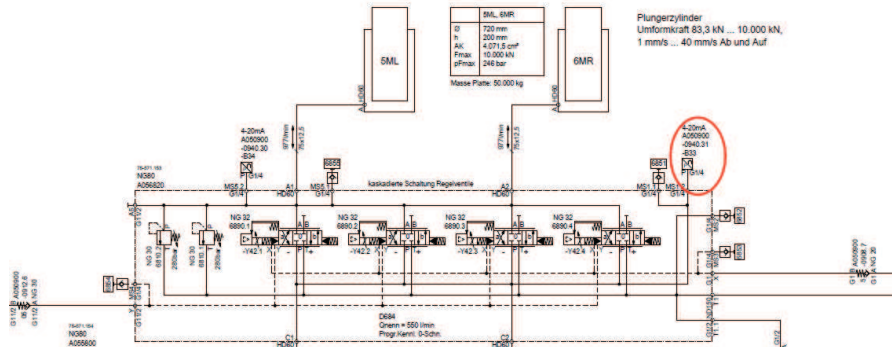
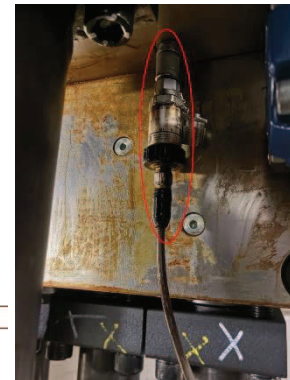
## Control Unit Check

The control units are fully functional. Some of the valve seals show some wear, which is due to their age.

On the control unit lower tappet of the middle cylinder, a pressure sensor is leaking badly and should be replaced along with the fittings.

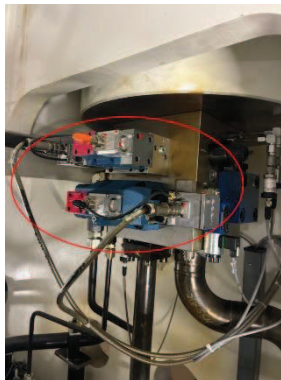
### Moog Valves

Prolonged storage causes resin to form inside the valve piston.

The Moog servo valves (17 pcs) should be removed during storage and transport.

The valves can be sealed internally with WD40. The valves should be labeled to prevent confusion.

On the control block side, the flange surface should also be sealed with blanking plates or flushing plates.

Before recommissioning, all servo axes must be flushed to prevent or minimize damage to the valves and any functional impairments.

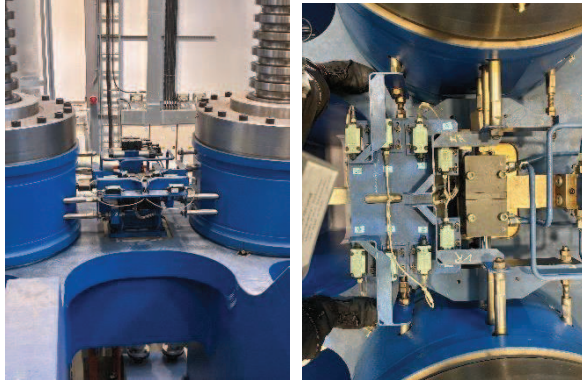
### Step Locking Mechanism

The step locking mechanism functions without any limitations.

The contact pattern on the columns is uniform.

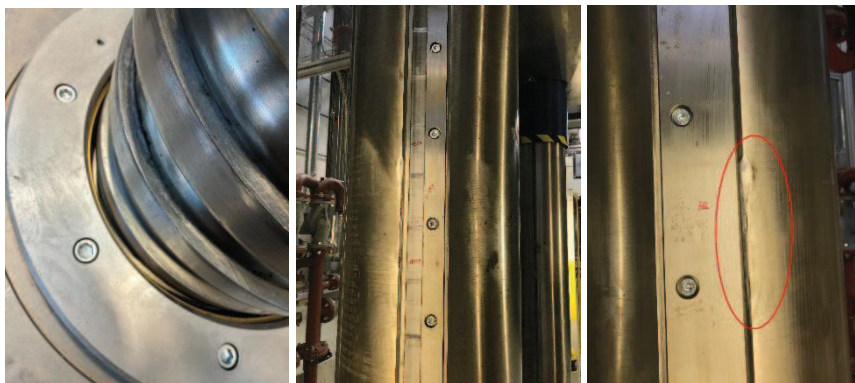
### Columns/Guides

The guide columns and locking steps are undamaged. RL-side, are some dents without technical significance.

The guideways on the columns show slight wear on the operator side (front left and front right).

The guides have excessive gap at the rear.

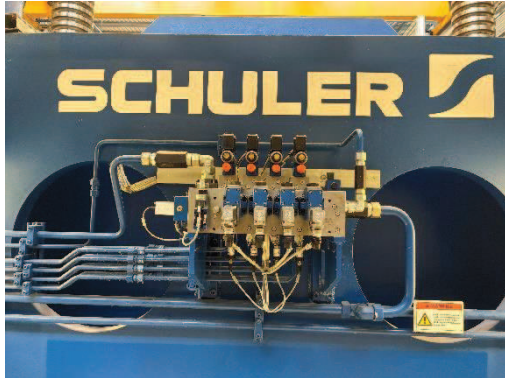
### Tool Control/Core Pulls

Functionality could not be fully tested because no tool was available.

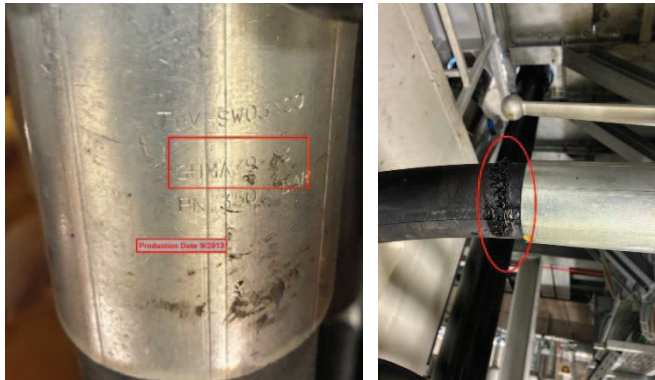
### Hoses

The hose assemblies are mostly from the same year the system was manufactured. The outer skin of the hoses is partially brittle or shows damage to the outer skin.

The recommendation is to replace the hoses due to age and environmental conditions.
